South African Maritime Safety Authority

Marine Notice No 3 of 2015

Man Overboard Smoke and Light Float

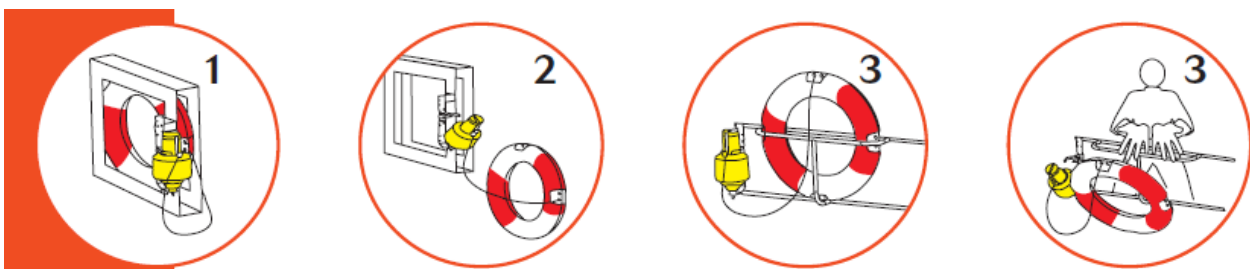
During surveys, it has been noted that the positioning of the Man Overboard Smoke and Light Float is not always correct. In the event of the lifebuoy being deployed, incorrect fitment/position of the MOB unit may result in non-deployment.

All South African Vessels required to carry a MOB smoke float arrangement should check to ensure that deployment will be effected as per manufacturer's guidelines, or as per the illustration below. It must be borne in mind that due to the falling pivot design of the Smoke and Light Float, it does not practically deploy if positioned inboard of the vessel's railing, or against an inboard bulkhead away from the vessel's side. Such positioning renders the unit ineffective.

All vessels which are required to carry such units should ensure compliance as soon as practicable from the date of publication of this notice.
