Marine Notice No. 22 of 2012

Findings of a casualty investigation into an accident to a containership due to defect in the electronic systems on board

Press Release 13/12

HANLA LEVEL CO., LTD. HFO-Flow-Sensors: Danger of Earth Fault

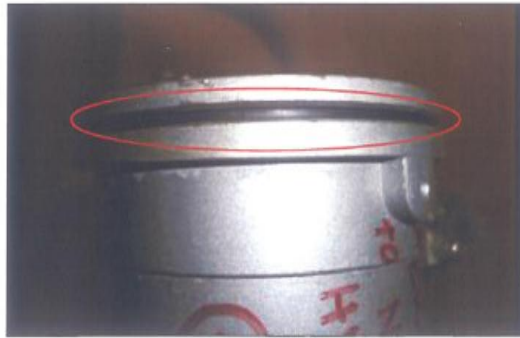
Picture 1

The failure occurs when the O-ring for sealing the sensor between the housing and the cover is not installed (picture 1). In this case the cover can touch a jumper on the board of the sensor (picture 2) which leads to an earth fault (-24 V DC).

The thread of the affected sensor covers should be shortened by at least 10 mm. When this counter-measure is done the cover can not touch the jumper even if the O-ring is not installed. Please note that the O-ring should be installed anyway!

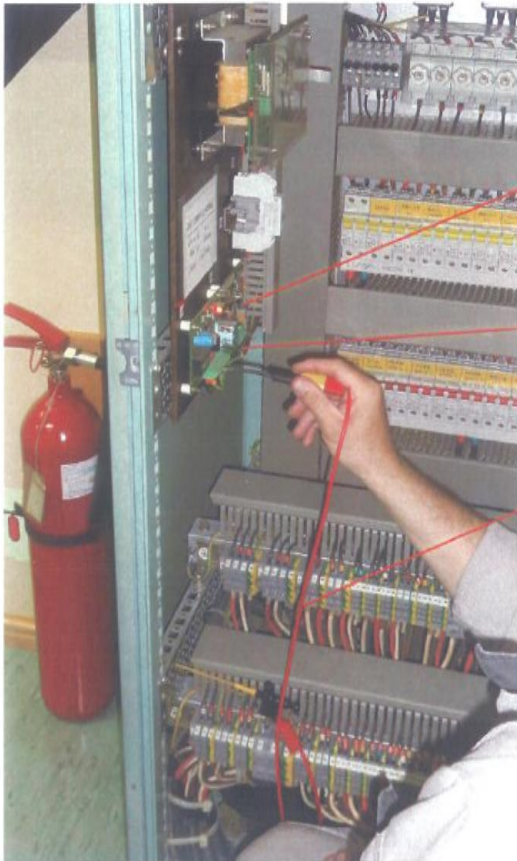
Cabinet: DC 24 V UPS FOR AMS & BMS

Board for earth fault detection

Ground wire (yellow/green, connected to the board)

Manual bridge between ground connection of board and ground of cabinet

If you find a sensor box without O-ring and with slight touching marks on the jumper, please also check if the earth fault detection module of the 24 V system is working correct (picture 3) before fixing the problem at the cover. Therefore connect the earth-port of the module to the ground of the cabinet by using a short line. If then the red LED of the detection module starts to shine, then the original earth line of the detection module is interrupted.
