## MARINE NOTICE NO. 13 OF 1998

### IMO RESOLUTION A.866(20).

GUIDANCE TO SHIP'S CREWS AND TERMINAL PERSONNEL FOR BULK CARRIER INSPECTIONS.

**GUIDANCE TO SHIPS' CREWS AND TERMINAL PERSONNEL FOR BULK  
CARRIER INSPECTIONS**

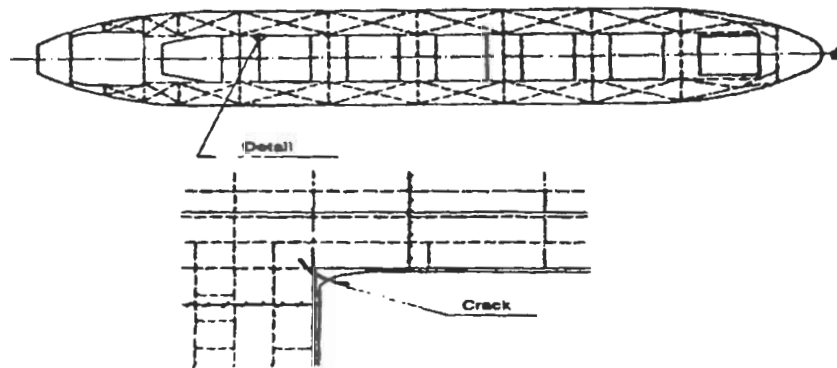
Figure 6: Cracking at hatchway

The large cargo hatchway openings reduce the torsional strength of the hull and invite stress concentration at their corners on the upper deck. In this regard, upper deck plating at hatchway corners is one of the focal points for cracking. Particular attention should be paid to these areas during inspection.

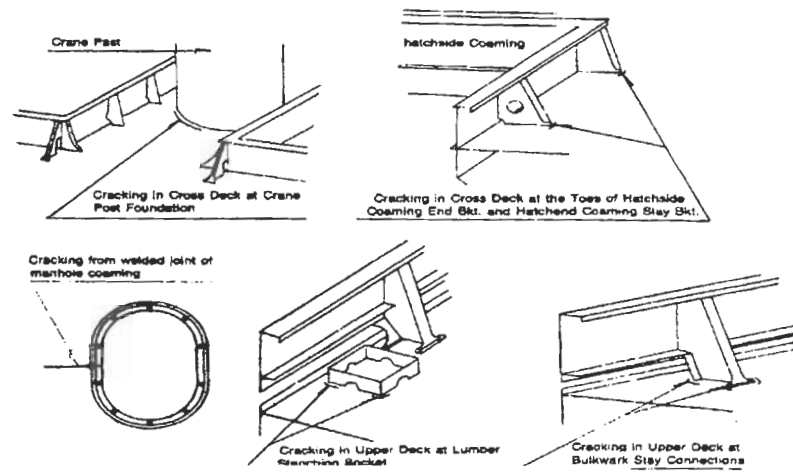
**Figure 7: Various crackings in upper deck plating**

Various metal fittings are welded to the upper deck plating. These installations may cause stress concentrations at the welded joints or have defects in the welds. Deck platings in the vicinity of manholes, hatchside coaming end brackets, bulwark stays, crane post foundations and deck houses, etc. are to be carefully watched for cracking.

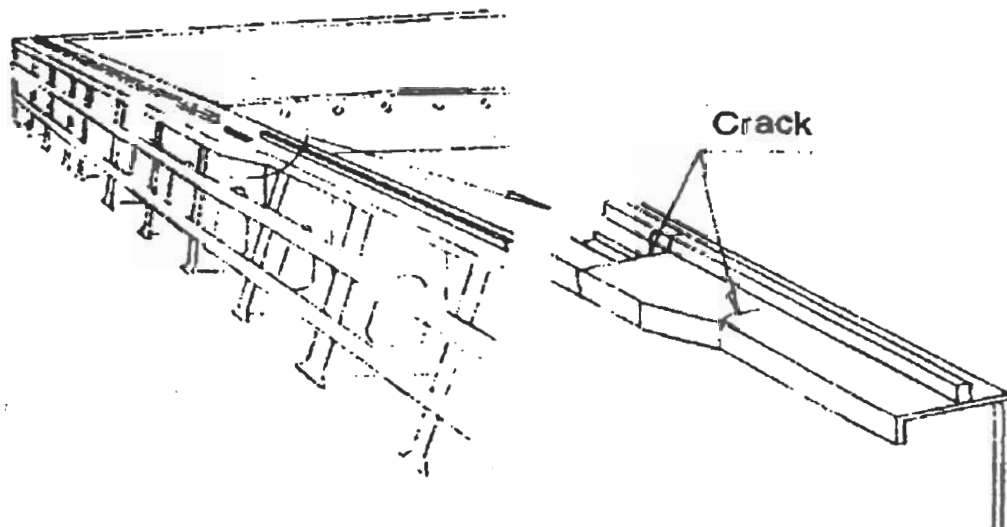
**Figure 8: Cracking in hatch coaming**

Hatch coamings are subjected to hull girder stress. Although they are not critical longitudinal strength members, they should be watched carefully to ensure that these cracks do not spread. Cracking may be initiated at defects in welded joints and metal fittings to the coamings that will invite stress concentration. Such cracking is considered serious to the ship's safety because it may be the initiation of a fracture on a large scale.

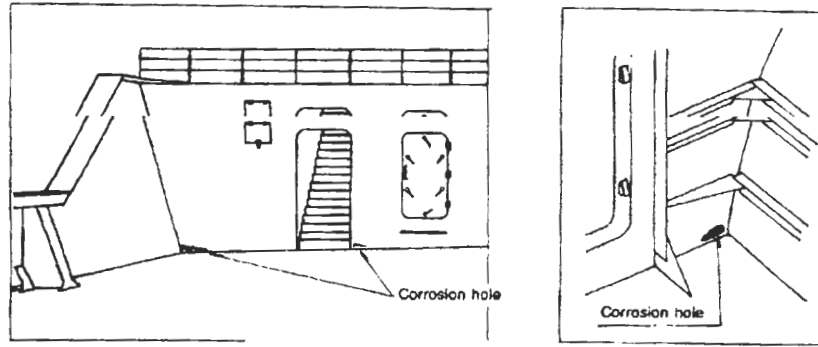
Figure 10: Forecastle end bulkhead

The bilges in forecastle space may cause corrosion of the bulkhead where it meets the deck. In flush decked bulk carriers, the boatswain store aft wall may be corroded in the same manner. Large bulk carriers generally do not have forecastle and have their boatswain stores down below the upper deck in fore peak spaces. Bilges left in such spaces also cause corrosion of the aft end bulkheads which separates boatswain store and No.1 cargo hold. Such wastage may lead to water ingress, cargo damage, cargo shifting, and/or stability problems.

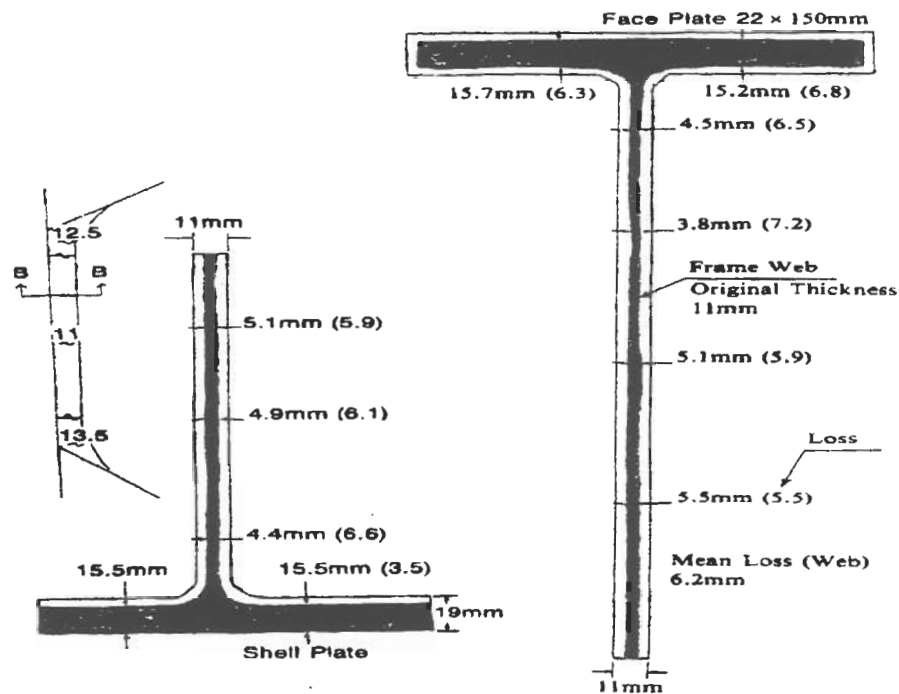
**Figure 12: An example of a corroded hold frame**

6.2.3 Among the various members composing cargo hold structures, the hold frames are usually the thinnest structures, especially at the web plates. In addition, the hold frames also have more surface area exposed, in that both surfaces of the plate are susceptible.

6.2.4 This may mean accelerated corrosion in the hold frames, the thinnest among all the members in cargo holds. If corrosion and waste become excessive, failure of hold frames invites additional loads to the adjacent ones, which may lead to failure throughout the side shell structure.

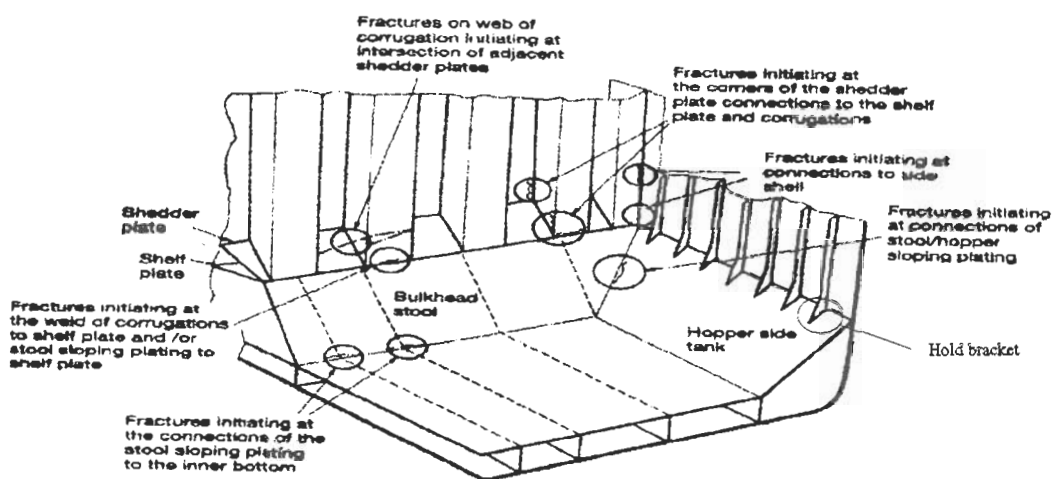
Figure 13: Typical fracturing at the connection of transverse bulkhead structure

- .1 *Fractures* at the boundaries of corrugations and bulkhead stools, particularly in way of shelf plates, shredder plates, deck, inner bottom, etc.
- .2 *Buckling* of the plating/corrugations, leading to the failure and collapse of the bulkhead under water pressure in an emergency situation.

- .3 *Excessive wastage/corrosion*, in particular at the midheight and bottom of bulkheads, which may look in deceptively good condition. This is created by the corrosive effect of cargo and environment, in particular when the structure is not coated. In this respect special attention should be given to the following areas:

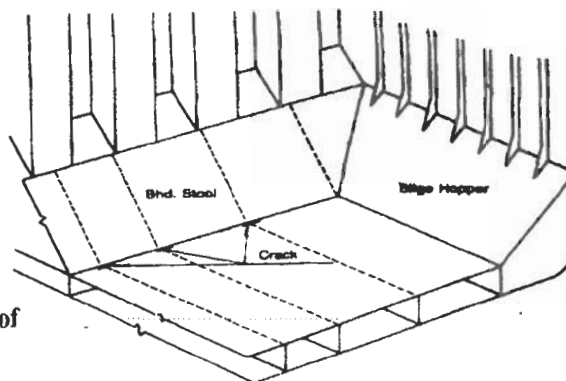
**Figure 14: Cracking at the connection of bulkhead stool and tanktop**

In bulk carriers having combination cargo/ballast holds, cracks may often be found at or near the connection of the stool of the transverse bulkhead and the tank top.

All capesize and panamax bulk carriers and some handy bulkers have combination cargo/ballast hold(s) to keep the necessary draught. The bulkhead boundaries of the spaces are designed to comply with the requirements for deep tank bulkheads. In these holds cracks may often be found at the connection between the transverse bulkhead and the tanktop. These cracks can be detected by visual inspection or by noting leakage from the double bottom tanks.

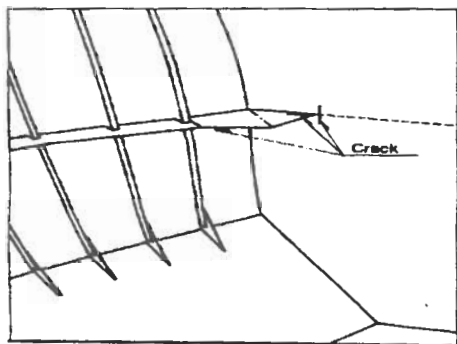
**Figure 15: Cracking around the collision bulkhead**

Side stringers and/or side shells in way of No.1 cargo hold along the collision bulkhead are often found cracked. This kind of damage is considered to be caused by insufficient continuity between fore peak construction and cargo hold structure.

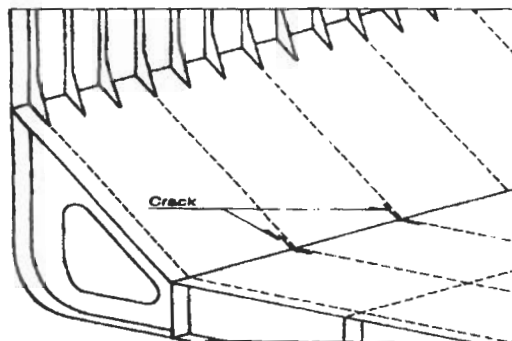
**Figure 16: Cracking in bilge hopper**

On large bulk carriers such as capesize and panamax bulkers, bilge hopper plating around the knuckle line may be cracked along the bilge hopper transverse webs. This is considered to be caused by insufficient local reinforcement.

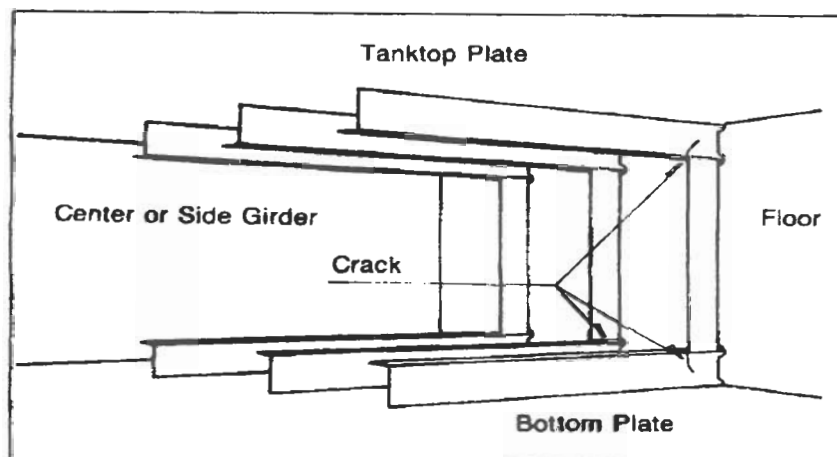
Figure 17: Cracking in tanktop/bottom longitudinals

Cracks may be found in the side, bottom and/or tanktop longitudinals at intersections with solid floors or bilge hopper transverses. Cracks also may be found in the floors or transverses occurring at the corners of the slots cut for longitudinals.

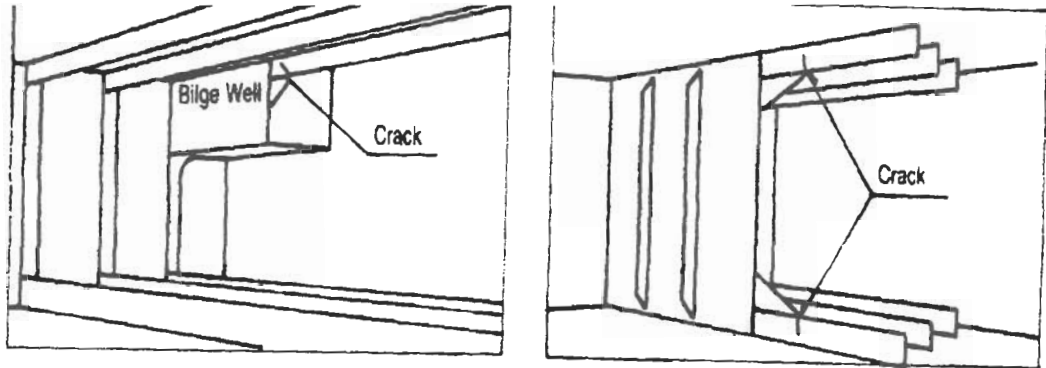
**Figure 18: Cracking at the end connection with side walls of bilge well**

Longitudinals may be cracked at the ends of additional (partial) side girders provided in the double bottom below cargo hold bulkheads or at the side walls of bilge wells for cargo holds, due to additional stress concentration caused by the structural discontinuity at those connections.

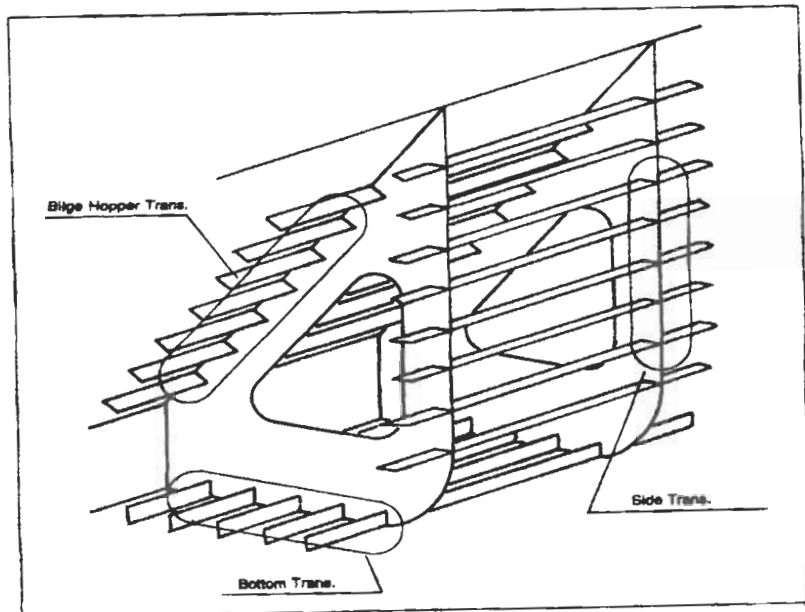
**Figure 19: Check points in bilge hopper transverse**

Cracks may be observed in transverse webs in bilge hoppers initiating from the slot openings for longitudinals and at the knuckled corners of the lower ends of the hoppers.

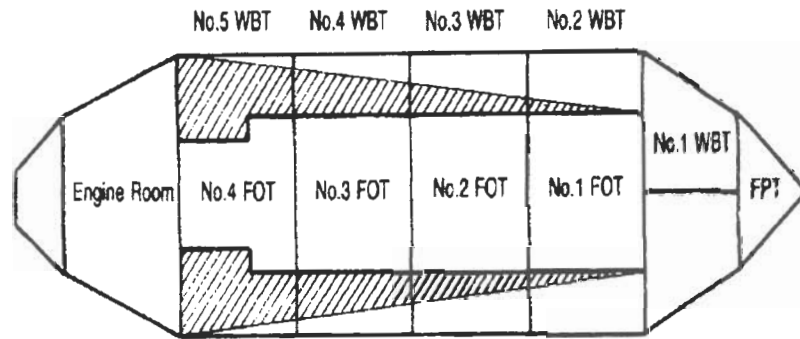
**Figure 20: Areas where heavy corrosion due to heat effect may be found (hatched areas)**

Since the late '70s, problems with heavy corrosion in double bottom water ballast tanks adjacent to fuel oil tanks have appeared. In some cases, the corrosion was worse in areas closer to the fuel oil tank boundaries. In those ships, fuel oil tanks were installed.

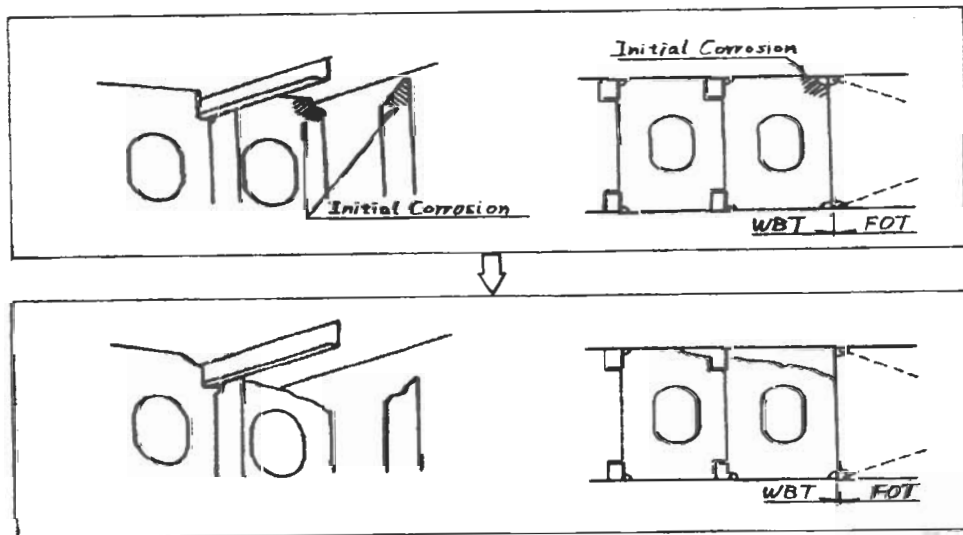
**Figure 21: Progress of corrosion in water ballast tanks adjacent to fuel oil tanks (FOT)**

The fuel oil heating system was adopted following changes to the properties of fuel oil, mainly an increase in viscosity. For economic reasons, ship operators began to use low grade bunker oil which needs heating in order to decrease the viscosity. At the beginning of this trend, the temperature required in the fuel oil tanks was not high enough to accelerate the corrosion of the steel in the adjacent spaces. However, in recent years, the grade of bunker oil being used requires the temperature in the tank to be 80°C or more. Such a temperature can accelerate corrosion of the steel in the tanks, particularly in the vicinity of the boundaries of the fuel oil tanks.

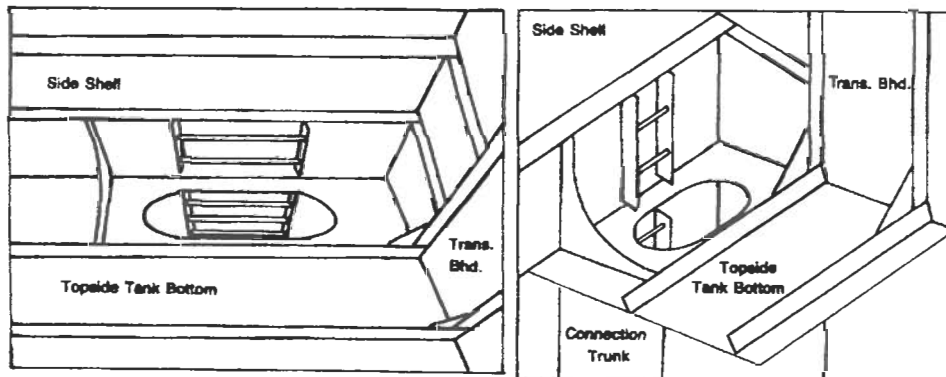
**Figure 22: Connection trunk entrance in topside tank**

6.5.2 Connection trunks provided between topside and bilge hopper spaces are to be carefully watched for signs of corrosion and waste of the steel works inside.

6.5.3 On some bulk carriers, bilge hopper tanks and topside tanks form one integral tank connected with trunk spaces. The inside surface of a connection trunk is liable to corrosion and should be examined carefully.
