Marine Notice No. 10 of 2008

Dangers of fumigated cargo

This marine notice brings to the attention of industry the causes of a recent fatality aboard a ship carrying fumigated cargo.

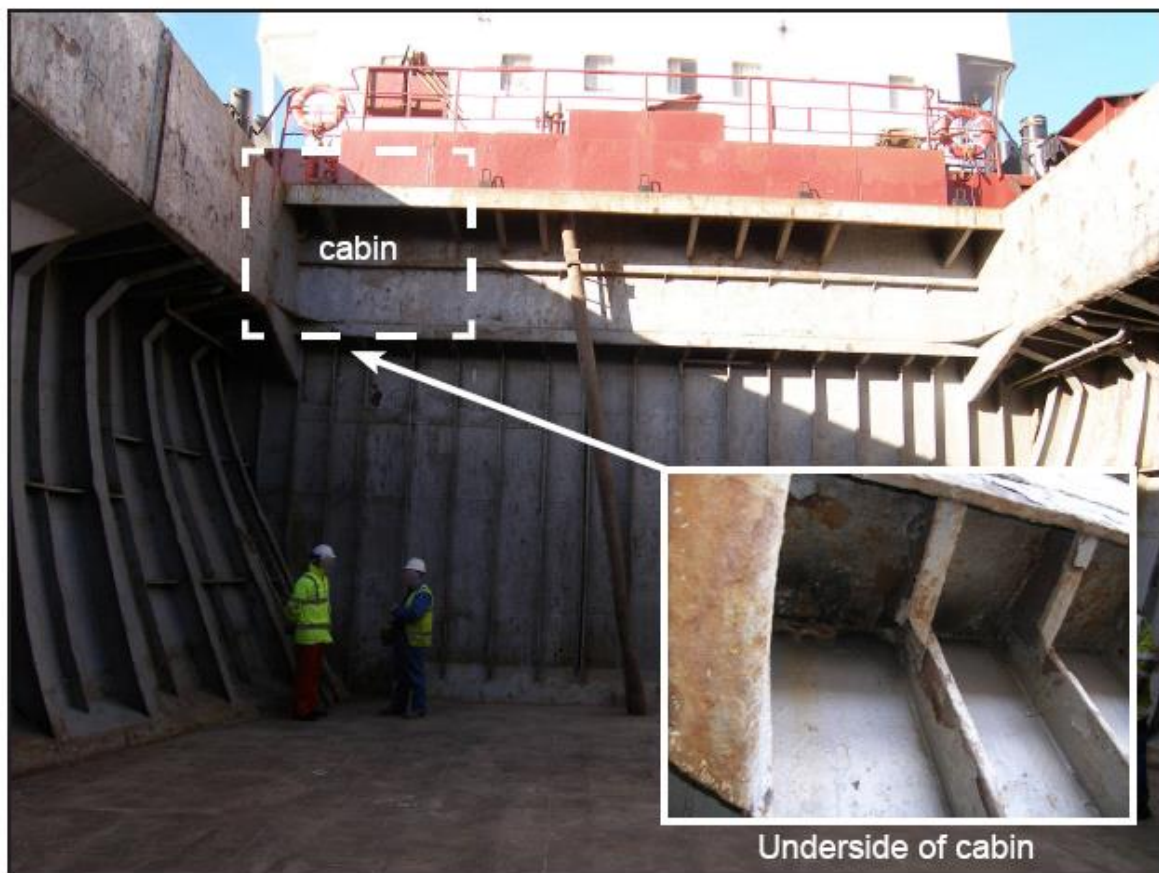
8 When the vessel arrived in port, tests revealed very high concentrations of phosphine gas in the able seaman's cabin and in the adjacent compartment. Both these spaces were sited over the aft bulkhead of the ship's cargo hold, with their decks extending over the cargo space by 0.5m (see photographs). Despite extensive testing, no obvious pathway was found for the fumigant to enter the cabin from the hold. It was only after the under deck area in the cargo hold had been thoroughly de-sealed that pin holes into the cabin were discovered.

- 2 **Masters** of vessels which have been fixed to load cargoes that require fumigation should ensure:
 - § The vessel can safely load the planned cargo. Special care should be taken to ensure fumigant gasses cannot enter the vessel's accommodation and extreme caution should be taken before accepting cargoes requiring fumigation at sea when the accommodation spaces extend over the cargo spaces.
