## MARINE NOTICE NO. 13 OF 1998

### IMO RESOLUTION A.866(20).

GUIDANCE TO SHIP'S CREWS AND TERMINAL PERSONNEL FOR BULK CARRIER INSPECTIONS.

**GUIDANCE TO SHIPS' CREWS AND TERMINAL PERSONNEL FOR BULK  
CARRIER INSPECTIONS**

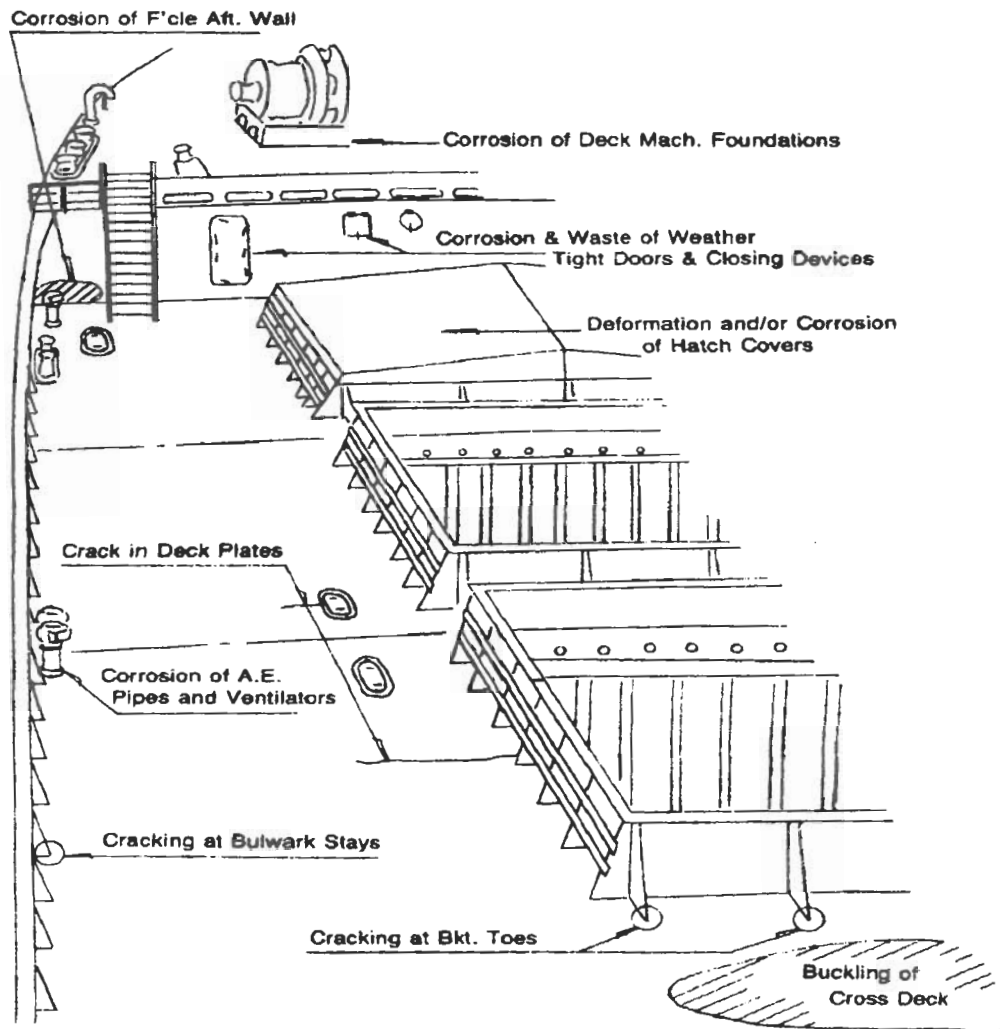
**Figure 4: Check points on the upper deck**

6.1.1 The longitudinally continuous upper deck of a bulk carrier suffers hull girder stress. The longitudinal bending causes an axial force on the upper deck that may cause cracking of the deck plate at the locations where the stress is concentrated.

6.1.2 Bulk carriers have cargo hatchways for the convenience of cargo handling facilities. These hatchways reduce the ship's torsional strength and invite concentrated stress at the hatchway corners which may be evident by cracking of the deck plates in these areas.

6.1.3 Cross deck strips come under stress by transverse bending. The transverse bulkheads provide transverse strength to a bulk carrier and the cross deck strips provide the strength to withstand the resultant axial forces in a transverse direction.

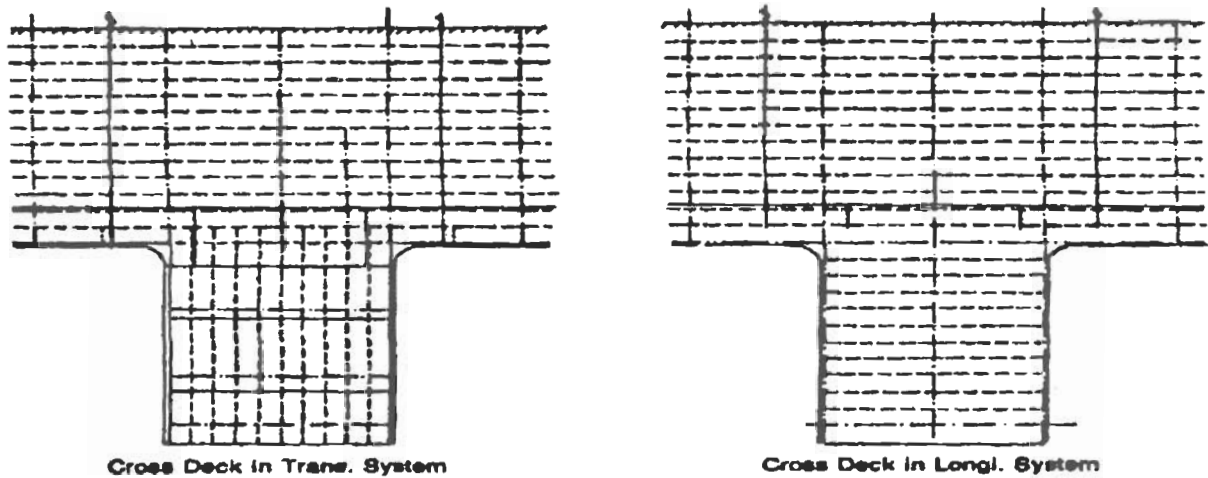
Figure 5: Comparison of stiffening systems for cross deck

6.1.4 Generally, **longitudinal** beams are arranged under the longitudinally continuous upper deck outboard of the side lines of the cargo hatchways. This is called the longitudinal system. When the deck beams for cross deck strips are also arranged in this manner, buckling of the cross deck strips may take place due to insufficient strength against the axial forces acting on them in a transverse direction. The transverse system is the preferred method of construction for cross deck members. Particular attention should be given to buckling of the main deck on those ships where the cross deck strips are arranged in the longitudinal system.
